Water Leak on FCCC2

January 30, 2008

Near Miss Water Leak

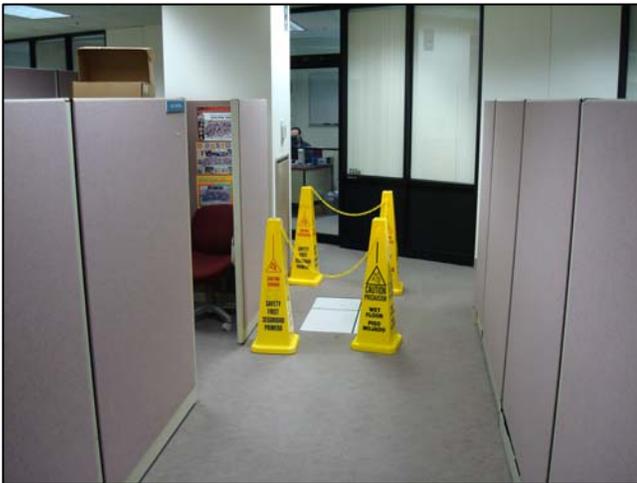
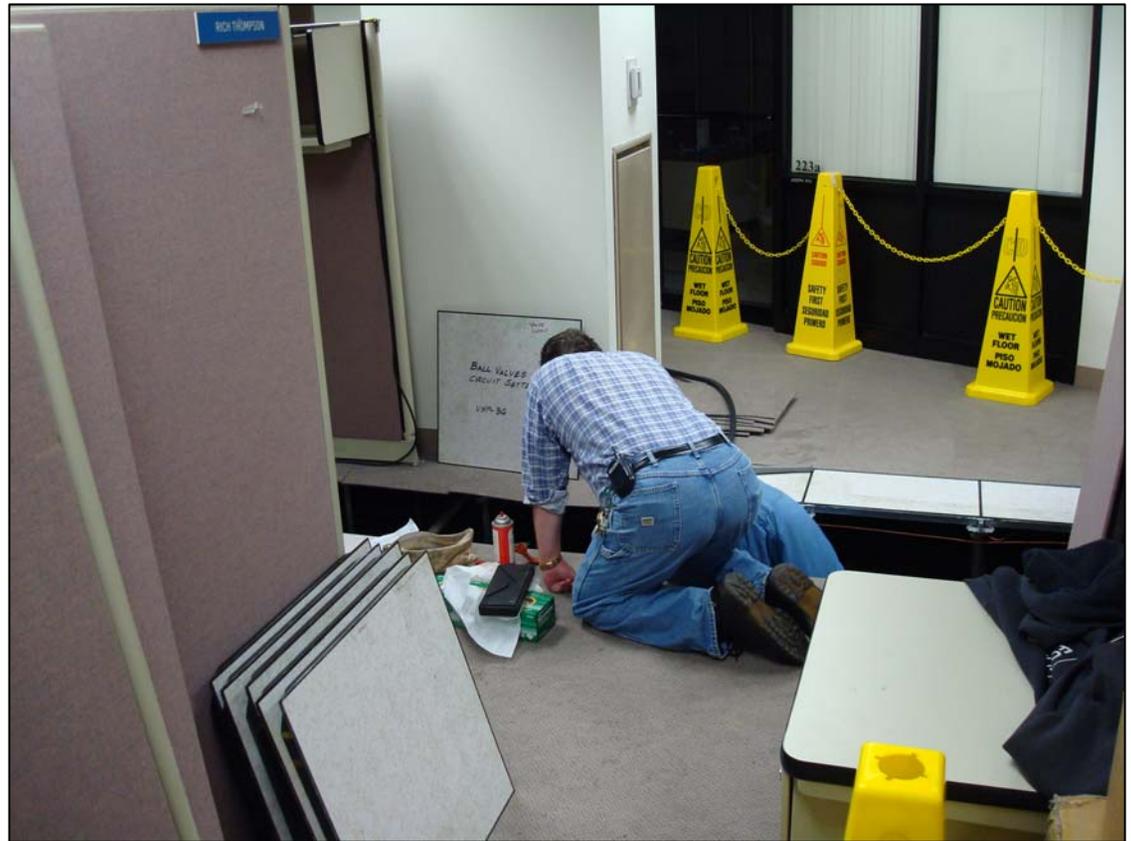
Office Area on FCC2

Office partitions
had to be
removed

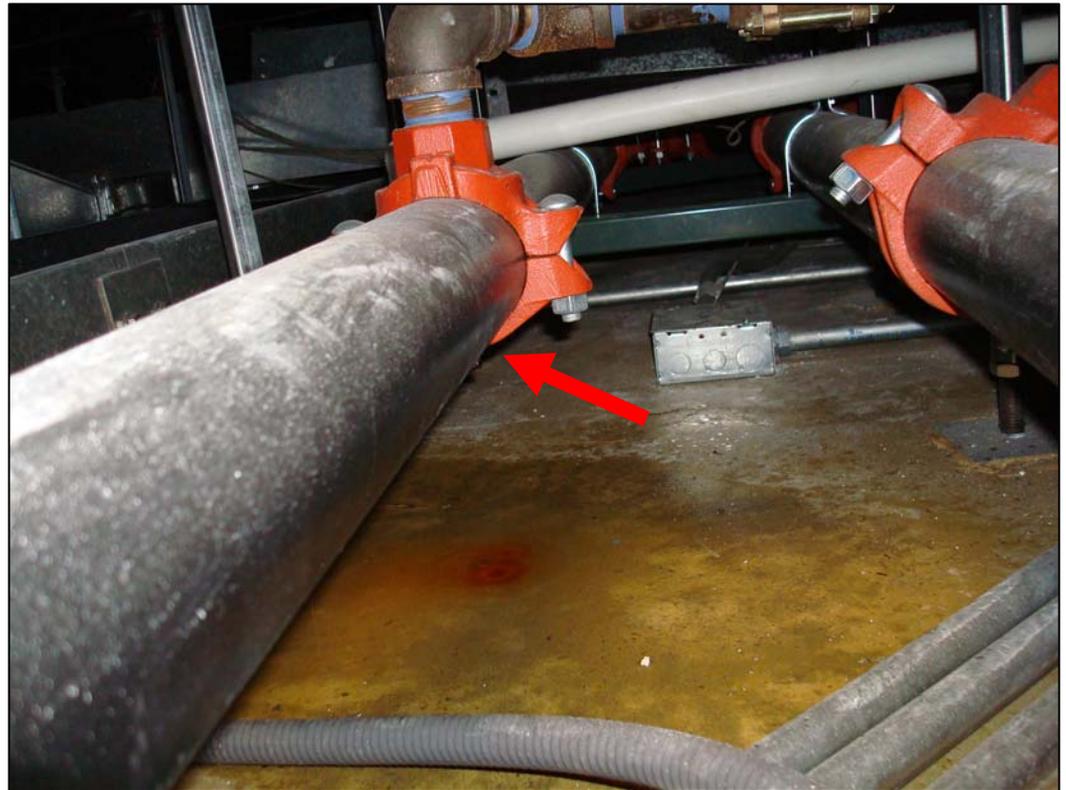
Source of the Water Leak

- 3" Victaulic schedule 10 steel pipe where a saddle was installed to feed a Heat Pump

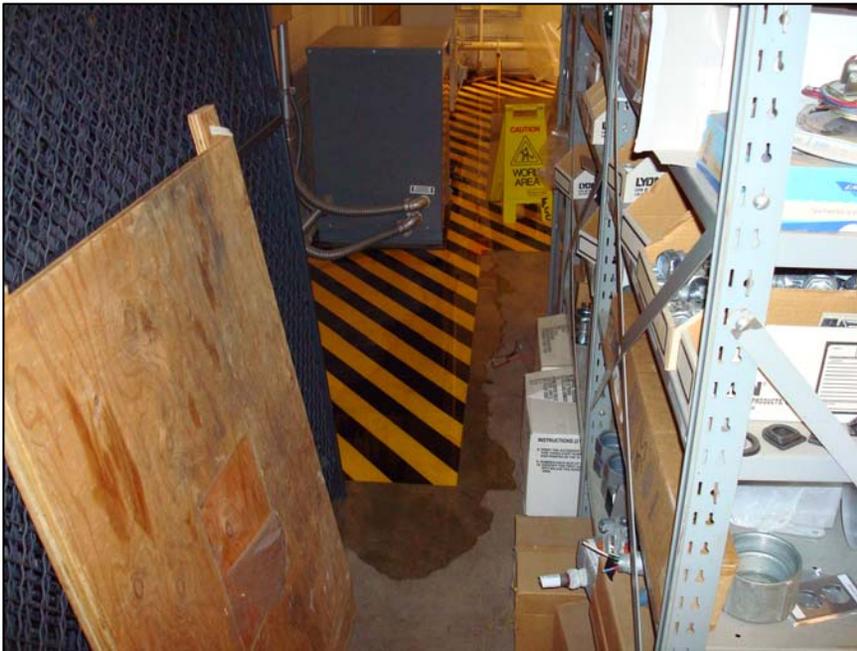
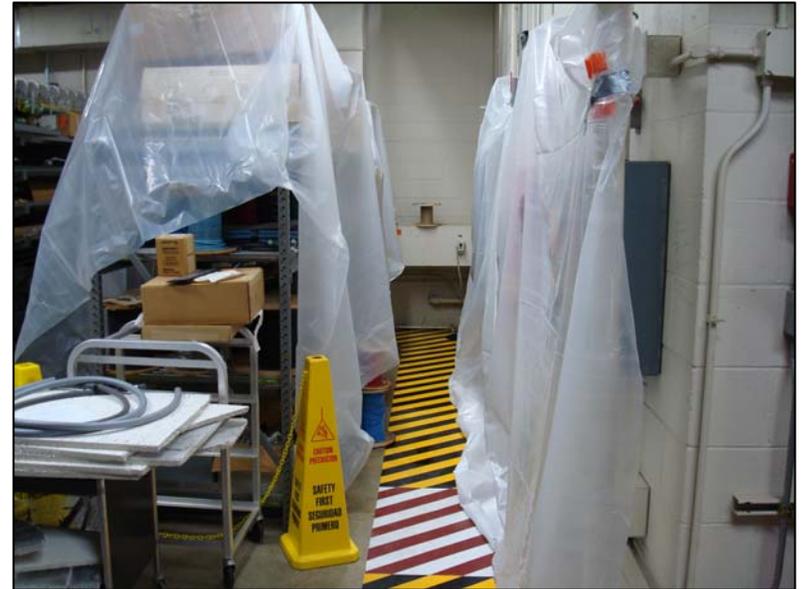
Water on FCC1 – ground floor

- Water on floor in the FCC1 utility area

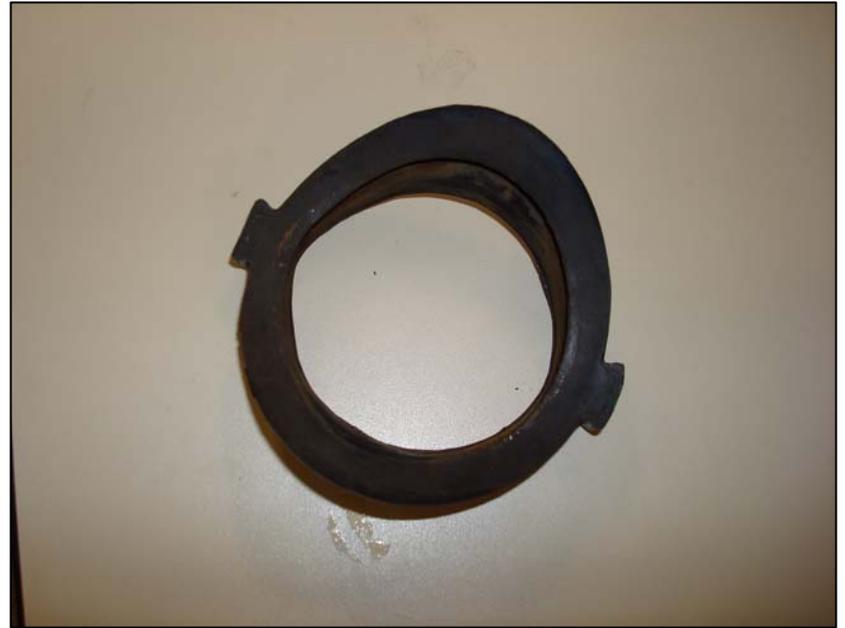
- The leak became worse on Thursday and required a short term solution (next slide)
- FESS collected measurements and information to gather required supplies to make the repair on Saturday (off hours) or sooner if the leak became worse

A rubber gasket's primary purpose is to create a constant tight seal. It was noted that over time this gasket was dried out and had lost its elasticity
