# **Root Cause Analysis for PBI000000000256**

## **GCC CRB Cooling Failure on 7 June, 2011**

Report submitted August 6, 2011

(CD-doc-4366)

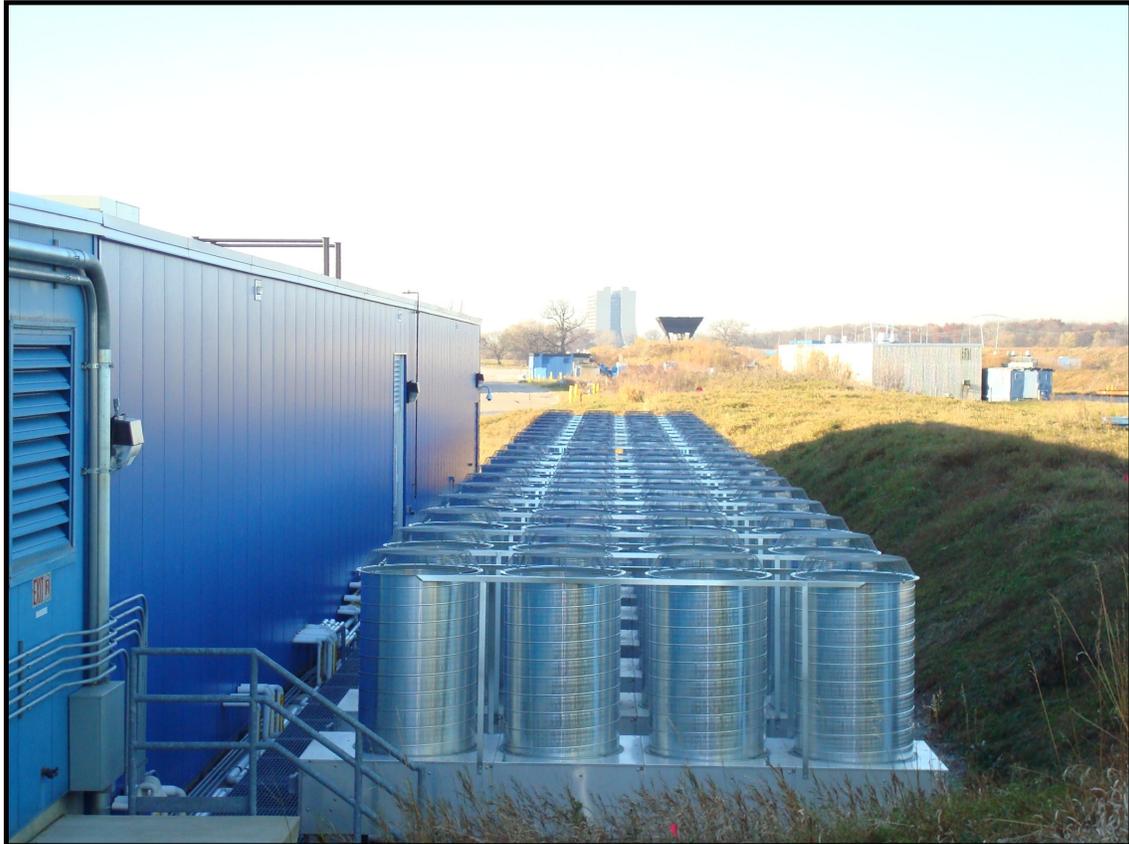
*Condensers for CRB and CRC, behind GCC*

The photograph above suggests several reasons for the poor performance of the condensers in hot, sunny weather with still air.

- The air intake is low to the ground, possibly restricting flow.
- The condensers are flanked by the building and a berm.
- The condensers are close together.

- The concrete pad under the condensers gets very hot.
- High foliage was present before the June, 2011 incident and cut afterward.
- Air in the space between the condensers and the building gets very hot!

The direct cause of the cooling failure was the failure of the condensers to return sufficiently cool, low-pressure, liquified circulating fluid to the CRACs. The placement of the condensers: close together, low to the ground, and flanked by wind obstructions, is very strongly believed to be responsible for that. When the fluid is not cooled, it returns to the CRAC at high pressure and temperature, leading to the HIGH HEAD alarm and shutdown.

The emplacement of the condensers was such that the air at the intakes would be too hot under a bad combination of weather conditions.

Aesthetic considerations may have been given too much weight in the placement of the condensers. The motion of air around and through the condensers was certainly given too little.

1. Air flow through the condensers must be improved. This almost certainly will involve moving some or all of the condensers, mounting them higher, and/or altering the nearby topography.
2. Until permanent improvements in the condenser functioning can be made, the mitigations should continue. These include cooling the concrete pad with water, keeping nearby vegetation low, use of portable cooling units,

- and proactively reducing heat production in the computer room when weather stresses the cooling.
3. The specification, acquisition and installation of future cooling systems should include careful consideration of the air flow through and around the condensers. This might involve computer modeling.
