***Lessons Learned***  
***Loose Ground Pin Suspected of Causing Internal Fault of***  
***250 vac 30 amp 3 phase Connector***  
***October 30, 2006***

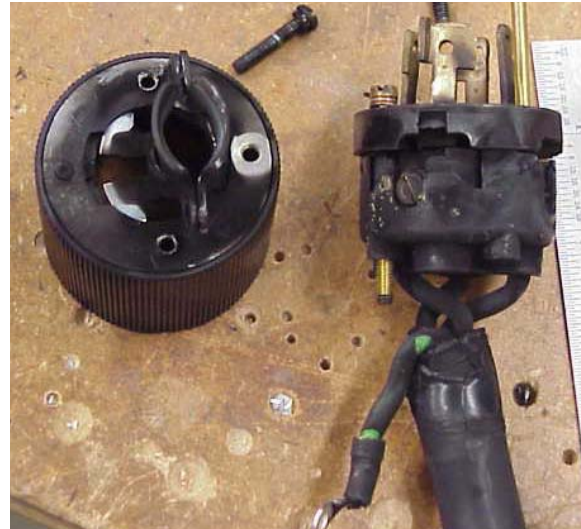
Faulted Plug

On Monday October 30th, an electrical technician was preparing to continue work on some equipment inside the MW9 Building electrical shop area. The employee had plugged the electrical connector for the equipment into a 30 amp 3 phase 208 VAC receptacle and was in the process of turning the plug slightly clockwise to lock it into place when the plug electrically faulted internally. The technician, although not required by any of the electrical safe work practices, always wore voltage rated gloves, leather hand protectors and an arc rated face shield when plugging in the equipment. Due to the use of the PPE, the employee was uninjured from the fault arc. The employee reported the incident to his supervisor and an investigation into the cause of the fault was initiated.

Before plugging in any electrical connector into a receptacle, a close examination of the plug connector should be made. The inspection should look for loose or damaged plug pins, damaged plug housing, or damaged or frayed cord. In installations where the older style Hubbell 45815 connector is used, the plug's ground pin should specifically be examined to insure the pin is tightly connected to the plug housing.

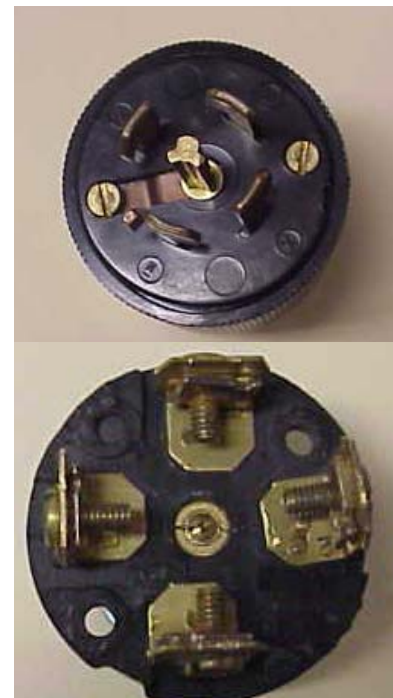
The plug being used on the equipment was a Hubbell Model 45815 four-pin-plus-ground twist-lock plug. This is an older style plug characterized by an irregular shaped ground pin. The cable grounding conductor is terminated at the external cable end of the plug body. The plug is rated for 30 amps 250 VAC 3 phase circuits. The failed plug was examined by the AD ESH Department Head and two members of the Electrical Safety Subcommittee (ESS), including the Subcommittee Chair. When the faulted plug was first recovered, the ground pin was observed to be missing and was later discovered on the floor by the receptacle. There was no evidence of arcing at the conductor blades. The flexible SO cord wired to the connector was fully intact. The insulation covering the individual conductors of the SO cord was in place and not brittle. Conductor arcing was limited completely to the interior of the plug body. The severe damage to the internals of the plug makes a positive fault diagnosis impossible. One of the most plausible causes is a failure of the ground pin connection on the inside of the plug. The ground pin is inserted through a phenolic shell and

Hubbell Model 45815 plug.  
External Plug Face (top)  
Internal pin configuration  
(bottom)

held in place by penning the end of the ground pin over a brass washer on the inside of the plug, much like a rivet. If the end of the ground pin were to break off, a small piece of the ground pin and the washer could move inside the plug, shorting out one or more of the phase pins inside of the plug.
