Device: Fisher Scientific Isotemp Oven
Model Number: 825F
Serial Number: 901N0001
Location: FCC 375
Incident Date: June 3, 2009

Incident Description:

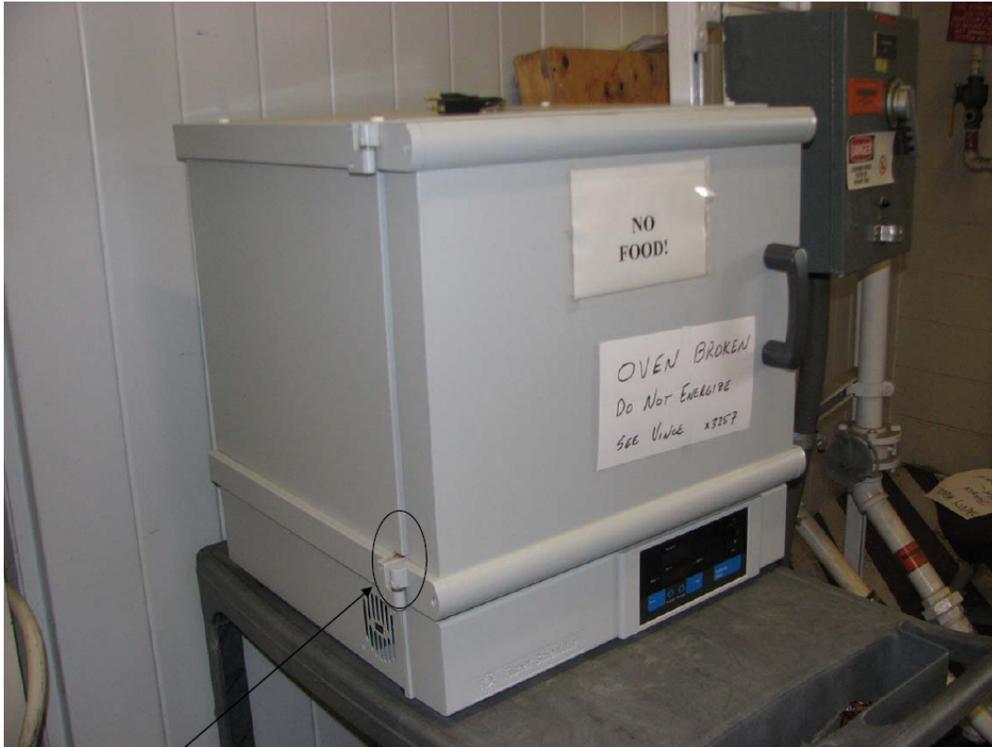
Fisher Scientific Isotemp Programmable Oven

Model 825F
Serial Number 901N0001

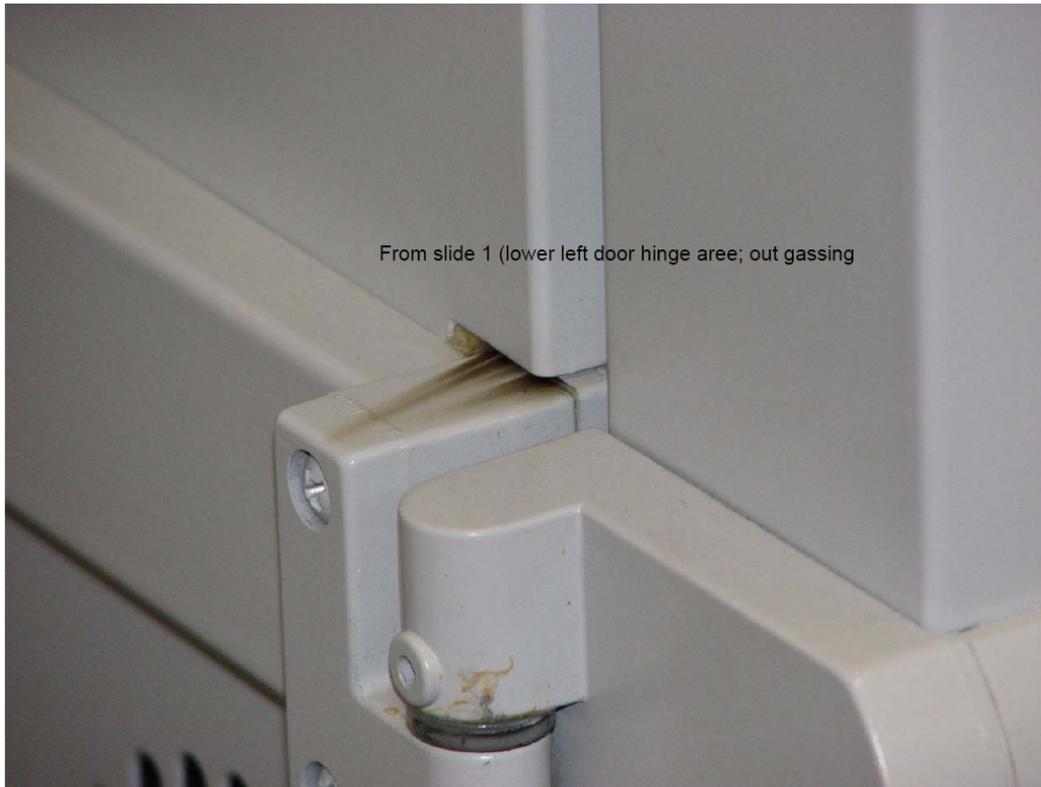
Fisher Scientific Isotemp Programmable Oven Closeup

The device shows evidence of heat damage and vapor escape (see photos below).

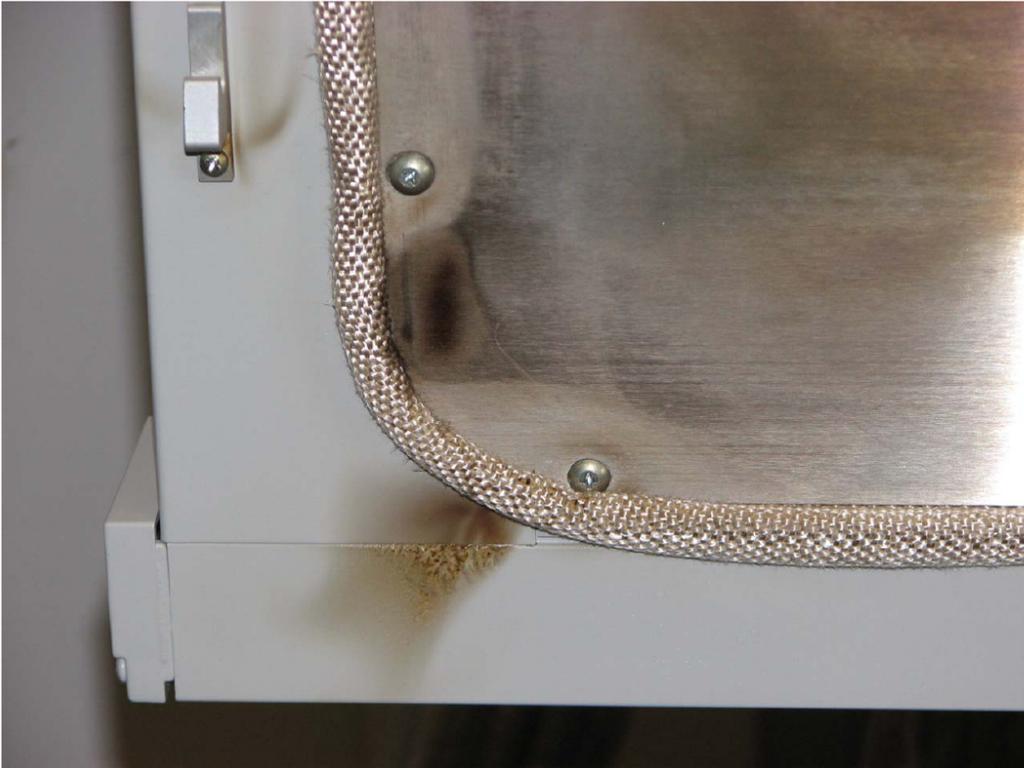
Fisher Scientific Isotemp Programmable Oven – Door Detail

Charred surface, blistering

However, even if the device checks out normally under such a test, it is recommended that the oven be serviced before it is used again.

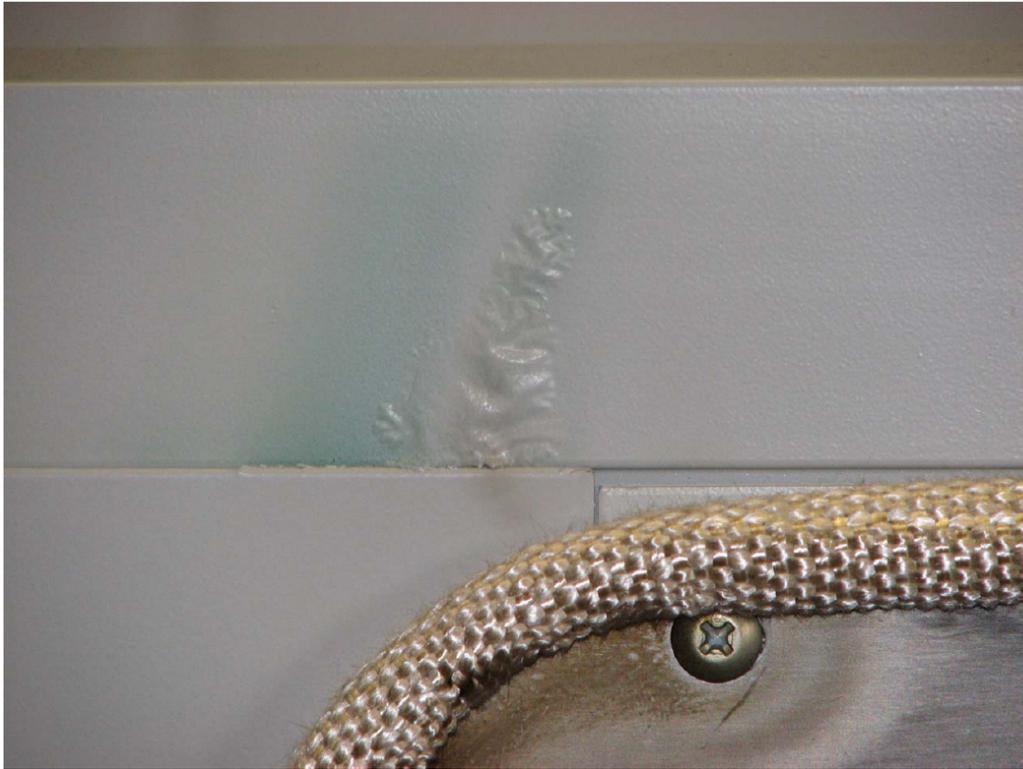
Fisher Scientific Isotemp Programmable Oven – Door Detail

Blistering

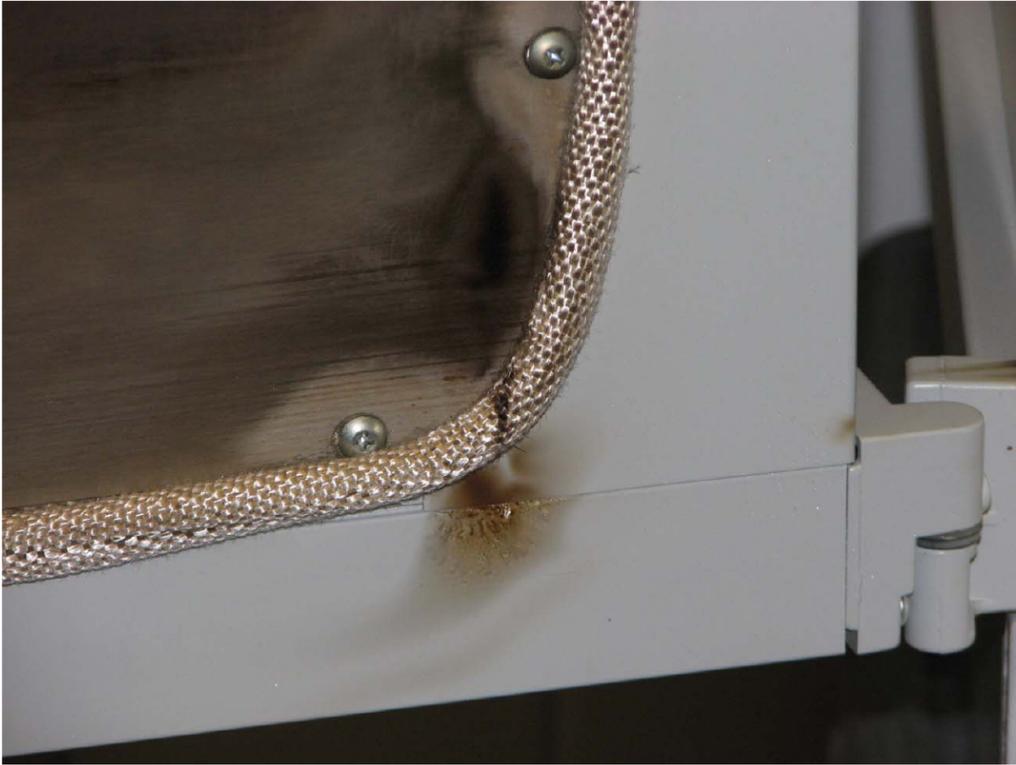
Fisher Scientific Isotemp Programmable Oven – Door Detail

Charred surface, blistering
